Dumping Problems on Someone Else

Good To Be a Curious George

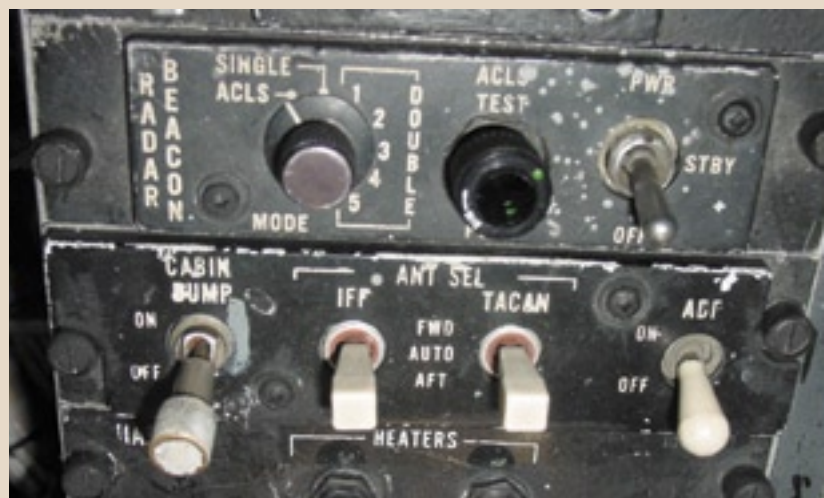
A closer investigation revealed that this panel had the TACAN and IFF antenna-select switches, but it also had the cabin dump switch, making it a downing discrepancy when the box was pulled out of an aircraft—this one had been taken out of aircraft 502. Maintenance control changed the MAF to a “down” discrepancy, and the jet did not go flying. Training was held with the avionics, egress and maintenance-control work centers.

Knowing whether a removed panel is an up or down gripe is critical to aircraft safety.

Miscommunication and lack of attention to detail resulted in the part being ordered improperly with a PROJ PRI (project-priority code) of AK7, indicating the aircraft was partial mission capable. It should have been ordered as AK0—not-mission capable. That simple coding would have made the gripe a “downer,” and it would have been flagged in the ADB for aircrew and maintainers to see.

We were a bit lucky to catch this problem before it was too late. Lack of communication, inattention to detail, and complacency are common factors in most mishaps. We had several “holes in the cheese” lined up but found the problem in time. It really is necessary to train maintainers correctly and do by-the-book maintenance to prevent these types of situations.
